What Happened?

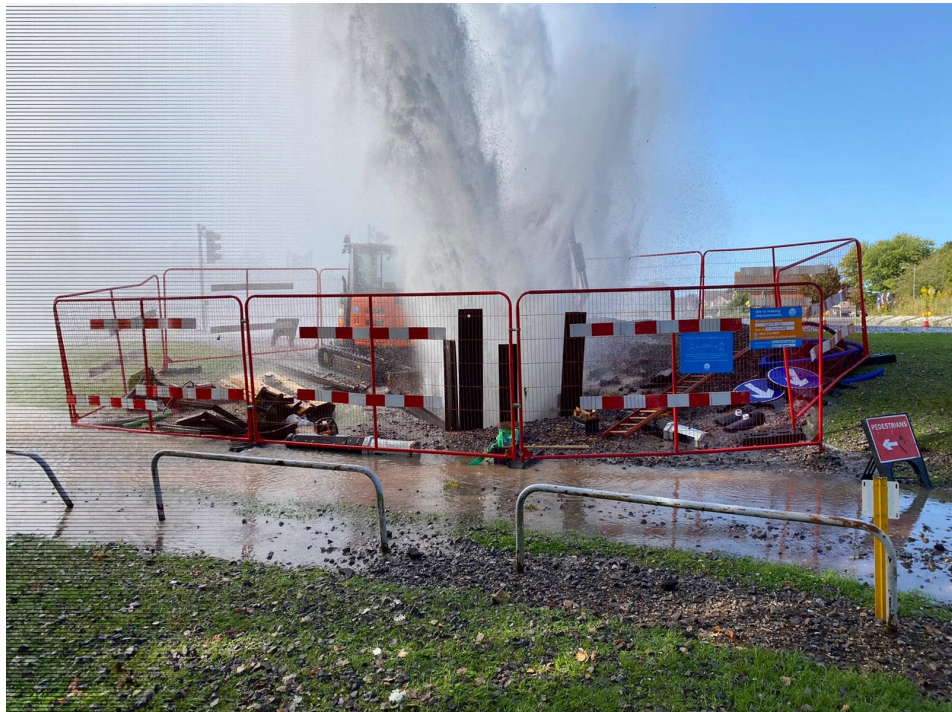
- On 17th September 2020, a Network Asset Maintenance team were replacing a District Meter between a 450mm GRP, 12" PVC and 2x 10" PVC Water mains.
- A PTW was requested and issued and works commenced over 2 days. As the team installed the temporary works they stopped for a break. Whilst viewing the works the soil gave way and water erupted showering the area in soil & stones and breaking windows on the excavator and van.
- No one was injured though did cause local disruption to the traffic

- The PTW did not identify the GRP main or the fact that the team were excavating .
- Requests were made to Network planners by Project Managers to confirm isolation would be done and this was confirmed however no instruction given to the NST to isolate the main.
- Onsite team & NST should have been aware that the mains required isolation as per ES26 procedures but failed to stop & check.
- PVC & GRP mains in this area were not isolated as required by the PTW and ES26 process
- Incident highlights a breakdown in ES 26 procedures in that various checks are necessary from site to confirm safe working systems are in place before excavating

Ensure you are aware of ES26 before working on live Mains.

Ensure that when working on sites next to live GRP/UPVC mains that you confirm isolation is in place before excavating.

If issuing PTW always check and confirm that you are aware of all site hazards, tasks and feedback from project managers & planners before issuing a PTW

Always complete a SHE5 dynamic RA prior to each task you carry out
