Learning Bulletin – High Voltage Service Strike – London Infra – JBrowne Construction

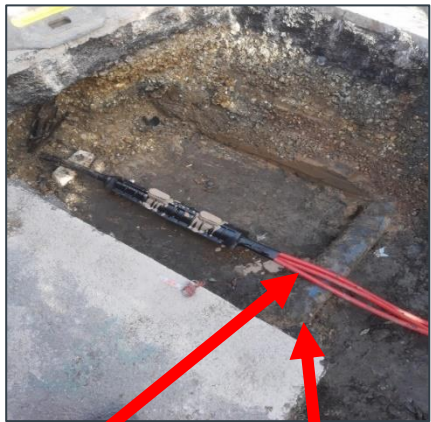
Point of impact

Newly installed pipe

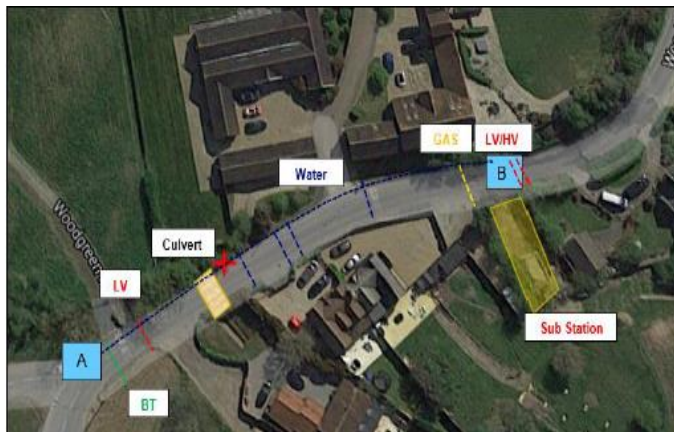
- The site team failed to identify the HV crossing from the poor-quality utility drawings provided to highlight the area as high risk
- The 11kV cable straddles two drawings/ tiles and was obscured by the boundary thick black line
- The team did not carry out a full sweep of the area using a G-CAT4 and relied on the utility drawings to identify crossing points and utility directions
- The process was not followed to complete a final sweep of the route prior to drilling
- Complacency from the site team may have been a factor due to this being the final drill, following the successfully drilled of 1.4 kilometres
- The cable was not damaged during the initial drill. Once the reamer (with the pipe attached) was brought back, the reamer came in to contact with the cable

Overlay of the utility crossing points on the directional drilling path exposed by the site team

- All personnel carrying out utility surveying need to be trained on the equipment (CAT & Gennie) to the correct level and on how to interpret utility drawings effectively
- Ensure all utility drawings clearly identify the services to scale, are in colour and that cross sections are shown and dated within the last 3 months - if unclear, stop work and escalate to your supervisor
- You must allow sufficient time and resources to positively locate and record all services
- A final sweep of the work area must take place prior to starting any directional drilling activity – Always follow your method of work and Risk Assessments
- Utility drawings should only be used as a guide to assist with surveys, not a checklist
- Ensure HSG47 - safe digging practices are applied, including trial holes to identify services
- Use locating devices with data logging capability, such as the G-CAT4
