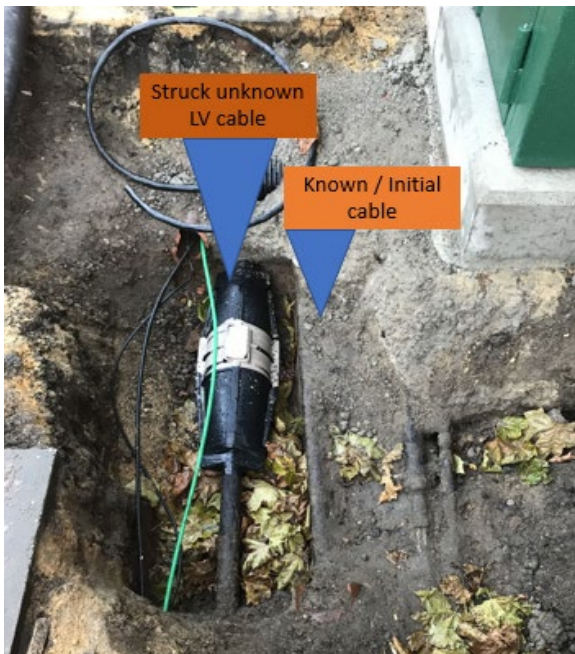
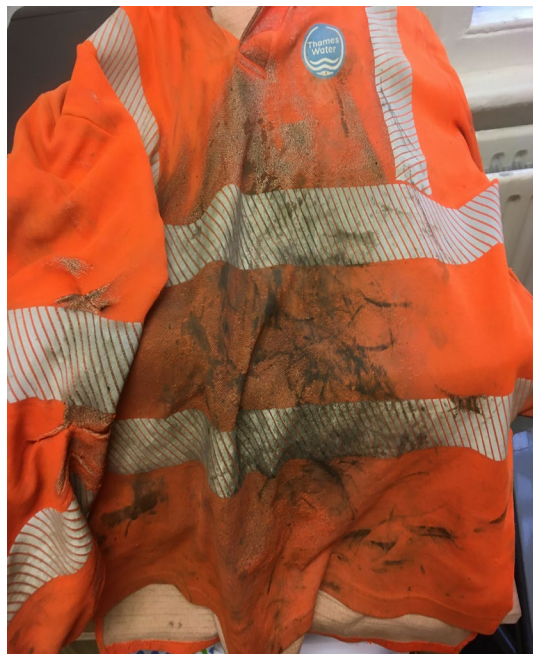
- On the 30<sup>th</sup> November 2021 UKPN had arrived on site to connect from one of three existing exposed cables to a newly installed control cabinet for a pumping station at Greyshott Road. UKPN Having identified on a previous visit to site which cable they would use to connect to the cabinet, on the morning of the incident UKPN then decided that they would need to connect to an alternative cable to the one originally chosen but this would require more earth to be removed in the excavation to enable them to make the connection to the cabinet.
- In the process of removing more earth to enable the connection the IP struck an unknown and undetected fourth cable in the location with the breaker, causing the cable to flash and as a result the IP suffered mild burns to his face and arms that required medical attention. The strike also tripped the supply to local residents properties.

- Lack of management, supervision and planning
- CAT and Genny was not used to re-scan the excavation.
- Permit to dig was not issued for the follow up dig
- Safe digging practices not adhered to the wrong type of tool used given the close proximity of the cables in the excavation.
- The IP was working on his own
- A perceived time pressure due to UKPN being on site to carryout the connection
- The drawings only showed two cables present in the location but they located three and hit the fourth.

- Always ensure that the job is properly planned and the correct procedures and permits are in place before commencement of the work.
- Before excavating ensure that the area is scanned using a Genny and CAT.
- Always carry out safe digging practices where there are known multiple services present hand digging, air lance ground conditions permitting would be other options to be considered.
- Ensure that all the dig teams have had the one day level two or equivalent service avoidance and location training .
- Ensure that when someone is digging that they are never working alone and that team members have had emergency first aid training.
- Stat drawings are only guides be always aware there might be more services present in the excavation.
- Ignore perceived time pressures safety comes first zero compromise at all times
