Learning Bulletin – Construction Fatality – Leadec Limited – Non TW

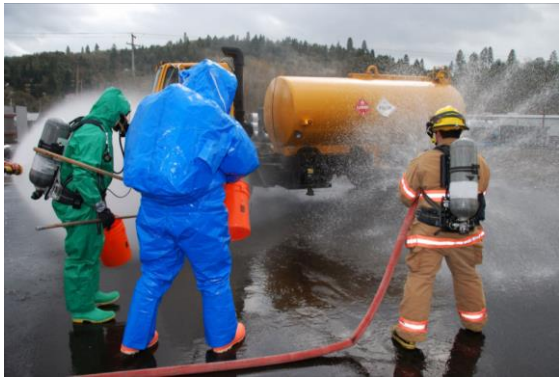
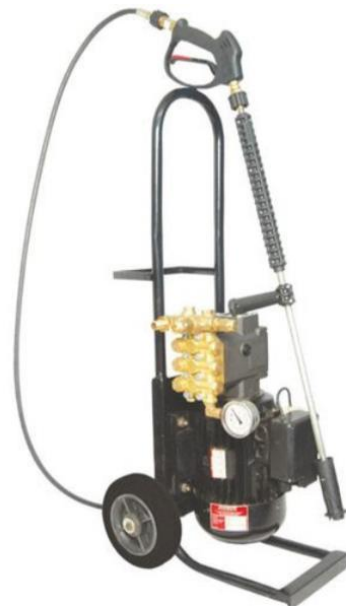
In June of 2017 an employee of a specialist industrial service company was fatally injured whilst cleaning waste-water pipes. The IP was using high-pressure jetting equipment to clean paint residue from pipes in a paint shop at a car manufacturing site when during the process the individual was struck by the end of the flexi-lance, causing a fatal injury.

The investigation by the HSE found that the company recognised the risks of operating high-pressure water jetting equipment, but they had failed to put in place appropriate measures to mitigate the risk. They had not implemented or enforced the use of various control measures such as a pressure regulator or an anti-ejection device, which were missing at the time of the incident and, training and supervision were also not up to standard.

- Always ensure the hazards associated with each task have been identified and the controls in place are communicated with all those involved
- Only operate equipment if you are fully trained and competent
- Ensure that equipment is maintained, inspected and suitable for the task
- Ensure you fully understand the Safe System of Work before proceeding
- **Zero compromise** – If you are unsure that the method is the safest way to complete the task, ask your supervisor and challenge
