# Learning Bulletin –High Potential Near Miss Pipe failure under test pressure – Eight20

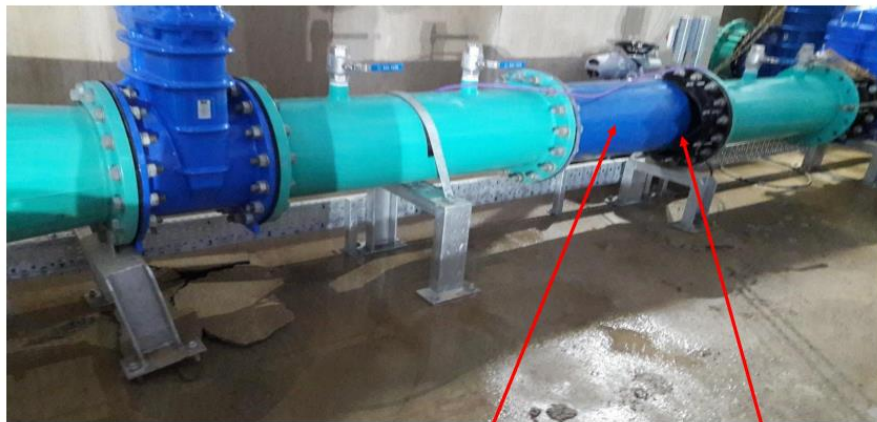
Temporary pipework failed at a non-bolted flange when subject to a pressure test causing damage to the internal fittings of a pumping station. A permanent valve was replaced with temporary pipework to facilitate swabbing and chlorination of 300mm main. Due to a lack of communication and a change to the programme the valve was not replaced prior to the pressure test being undertaken. No personal were working in the dry well, however sub-contractor staff were in the MCC room a floor above within the pumping station. Damage was caused to pipe stand supports and concrete base.

Temporary section of pipe

Point of failure

- All those taking part in the activity must be briefed on the Safe System of Work
- Ensure all steps have been followed which are specified within the RAMs prior to any pressure test taking place
- When there is a temporary modification to any design the Principal Designer MUST be consulted and written confirmation obtained from the Principal Designer.
- A Test and commissioning plan is to be reviewed to reflect any change of design and programme
- Ensure that when there is a change to the programme of works, ALL stakeholders are to be consulted and communicated on the updated design, test and commissioning plan
