# Learning Bulletin – Joint Failure during UPCV Pressure Testing – Alcester STW Non TW

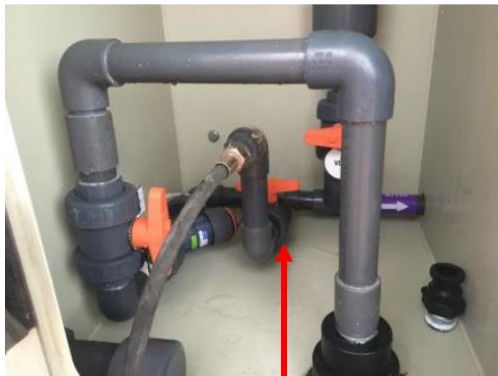
A factory assembled dosing kiosk had been installed and connected to a ferric tank. The pressure test was required to achieve and hold 6 Bar as per the factory acceptance test document, however at 3 Bar the joint failed, was ejected from the cabinet and narrowly missed the pressure tester.

Point of Failure

- Always ensure RAMS are followed and include measures to prevent or reduce the likelihood of any operatives being in the danger zone during pressure testing activities
- Ensure task specific PPE is detailed in the RAMs for pressure testing and worn by anyone within the working area
- Guards or barriers may be required to eliminate the risk of being struck by a flying object
- **Zero compromise** – If you are unsure that the method is the safest way to complete the task, ask your supervisor and challenge

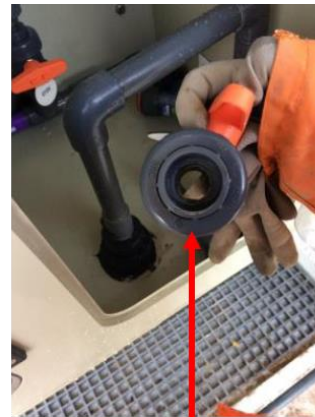
During the first inspection of the joint a lack of glue around the seal was identified.

1st inspection of joint indicates lack of glue
