What Happened?

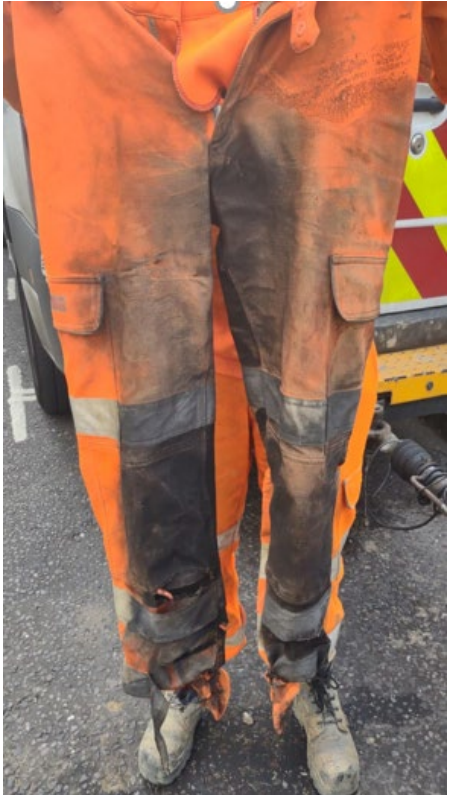
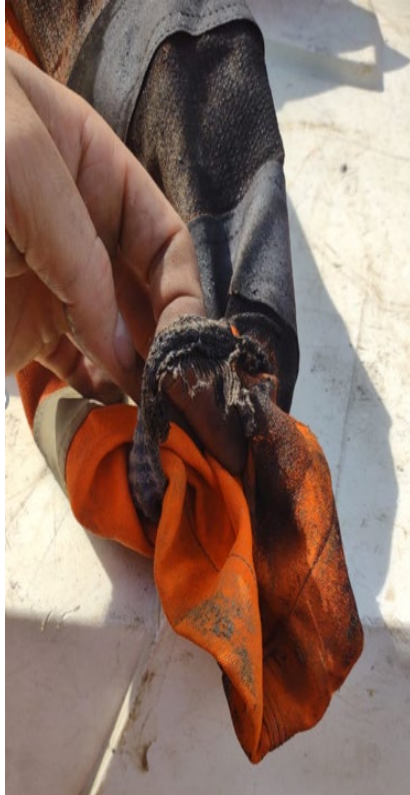
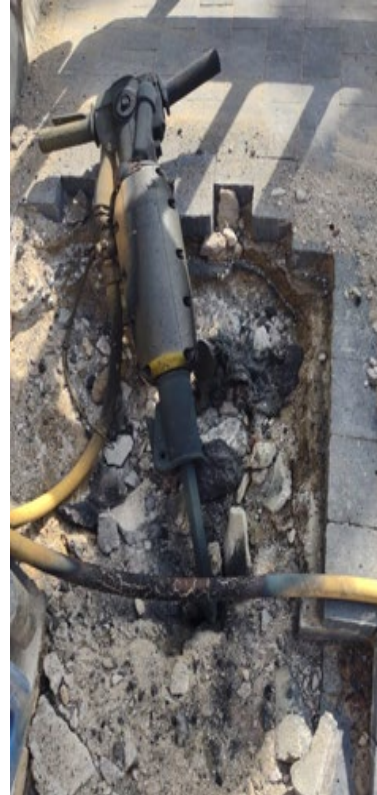
- Team were tasked to excavate on the footway and customers property to locate a leak on a water service pipe.
- The team completed elements of the safe system of work, but not all.
- During excavation with a jack hammer, breaking out concrete, the operative has damaged a galvanised steel duct and struck a low voltage electrical supply (3 phase 415v) 200mm below the surface.
- As a result of the strike, the service '*flashed*' and the operative suffered superficial injuries to the lower right leg and a further injury to an area on the left side of the stomach.

- Team failed to follow safe digging procedures by:
 - Using mechanical equipment within 500mm of a known service.
 - Not identifying and marking up a service shown on the service drawings.
 - Not escalating to a supervisor the presence of a known service in concrete.
- Permit to break ground call, did not include the supervisor doing a video call or checking pictures of the site which is part of the safe system of work.
- Injury occurred due to socks being tucked into arc resistant PPE

- Always follow Safe digging procedures, they are designed to protect you, your peers and members of the public (RAMS, HSG47, site specific procedure).
- Reassess the area to be excavated and escalate any finding to supervisor when unsafe conditions are observed.
- All identified services should be clearly marked up, extended outside the work area and in the excavation. Renew mark up if top layer has been removed.
- Don't just wear your PPE, wear it correctly to protect you fully.
- If in doubt STOP!
